IMPORTANT WINDSHIELD REPLACEMENT INFORMATION FROM YOUR PARTNERS AT COACH GLASS

STRUCTURALLY COMPROMISED OR OUT-OF-SQUARE WINDSHIELD OPENINGS:

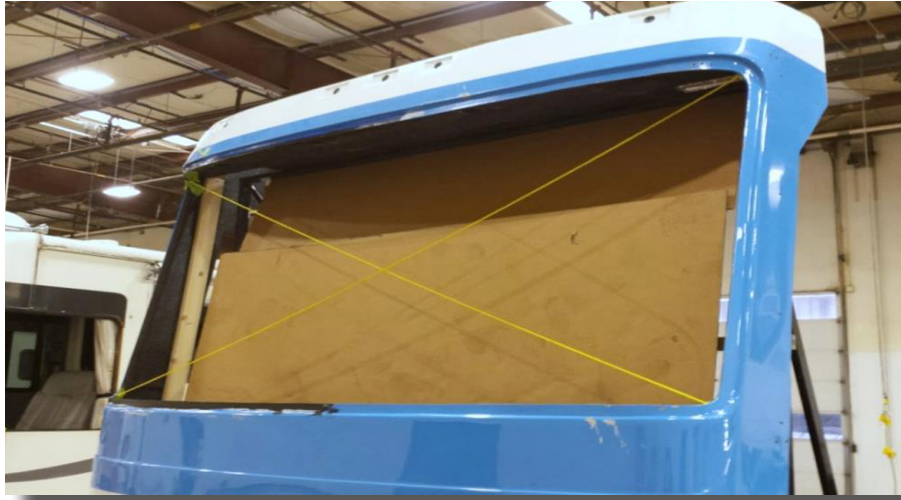
Before reinstalling a replacement windshield, we recommend confirming that the coach is sitting with a square opening. To do this, ensure the coach is sitting on level ground at ride height and measure diagonally across the windshield as depicted in the photo above. Ideally, the diagonal measurements should be within 3/8" difference or less before reinstalling a replacement windshield. Having more than 1/2" difference in diagonal measurements is generally the core issue of an improper fit of the windshield.
